THE UNITED STATES  
STRATEGIC BOMBING SURVEY

EFFECTS OF  
THE ATOMIC BOMB  
ON  
NAGASAKI, JAPAN

Physical Damage Division

June 1947

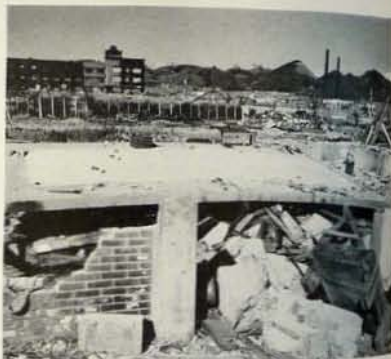
Remarks: Photos 64 and 65.

Photo 65.—Group 5. Building 7. Looking north at overturned roof slab.

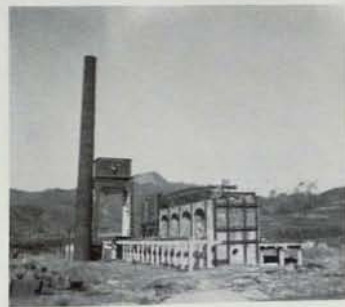
Photo 68.—3,700 feet from GZ. Group 6. Coking ovens under construction. Looking west.

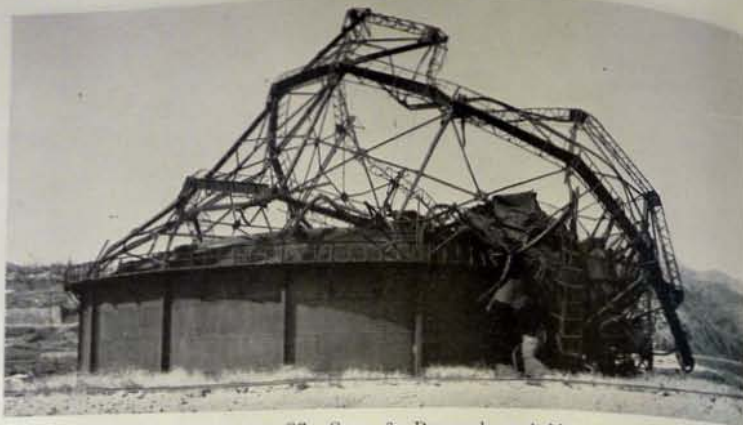
Photo 70.—3,200 feet from GZ. Group 6. Damaged gas holder looking west.

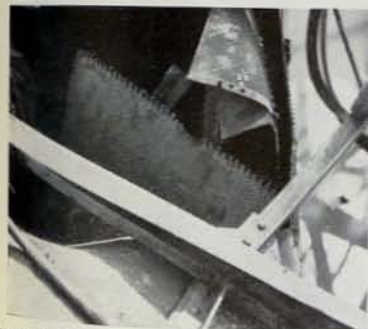
Photo 73.—3,200 feet from GZ. Group 6. Gas holder, ruptured top plates.

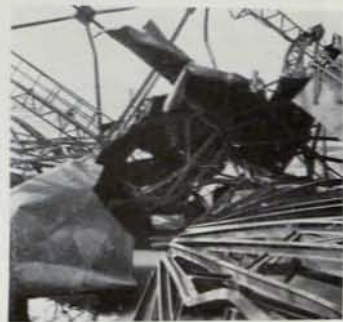
Photo 74.—3,200 feet from GZ. Group 6. Gas holder, collapsed framing.

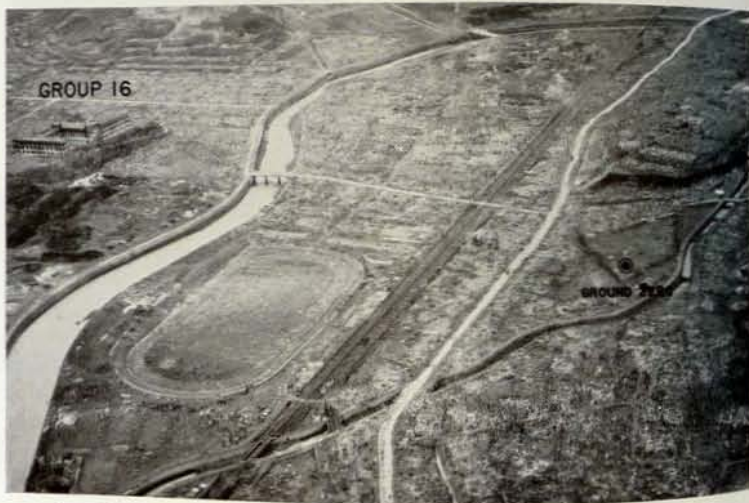
Photo 76.—1,200 feet from GZ. Area included in Group 12. Ground Zero at right of photo.

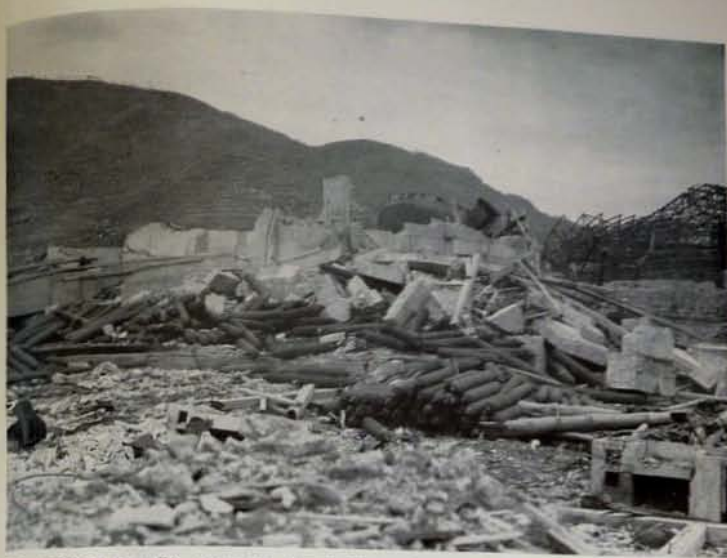
Photo 77.—1,500 feet from GZ. Group 12. View looking southeast at brick and concrete building near south end of group area.

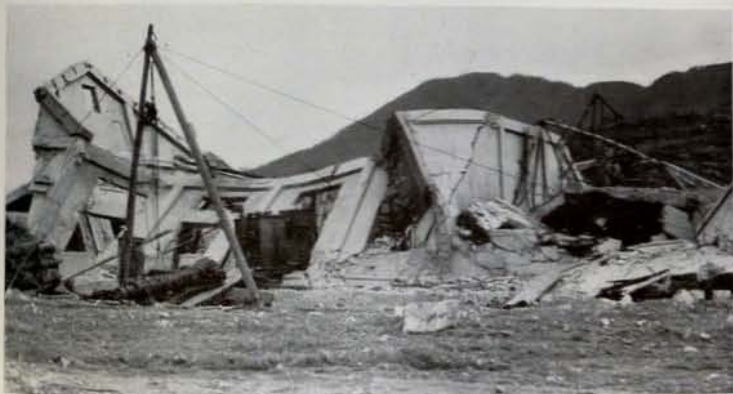
Photo 78.—1,400 feet from GZ. Group 12. View looking southwest at concrete building near south end of group area.

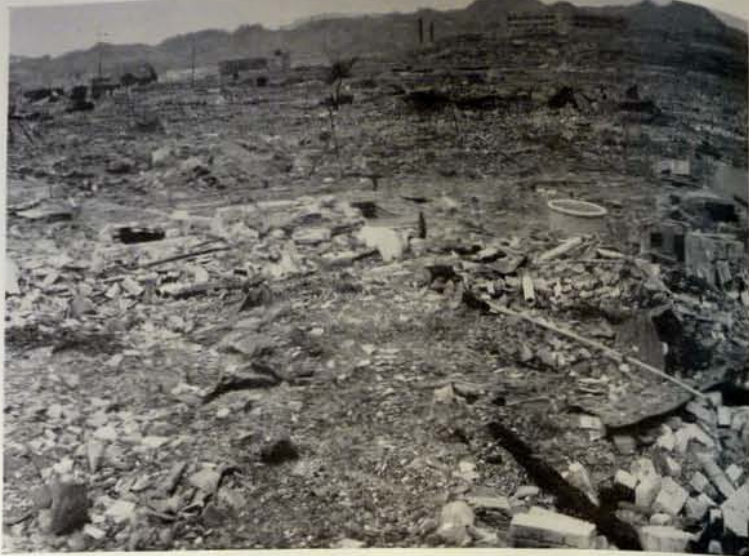
PHOTO 79.—Group 12. General view looking northwest from Urakami River bridge.

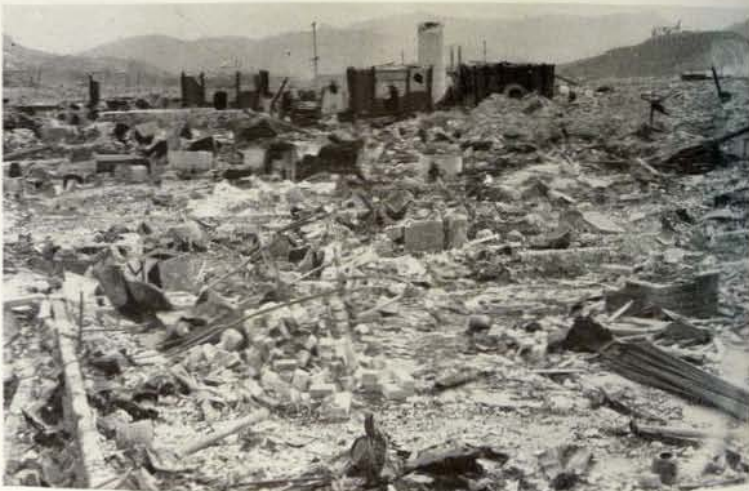
PHOTO 80.—Group 12. General view looking south. Brick kilns in background.

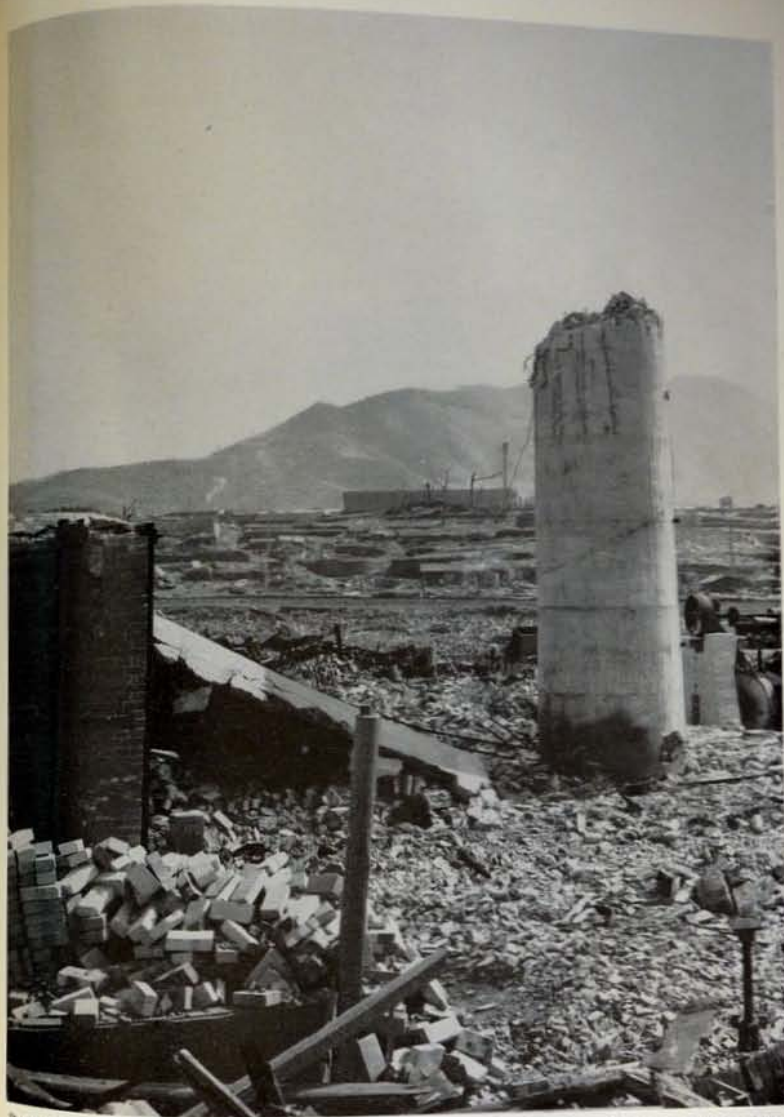
PHOTO 81.—1,600 feet from GZ. Group 12. Looking east toward Nagasaki prison. Brick kiln at left of photo.

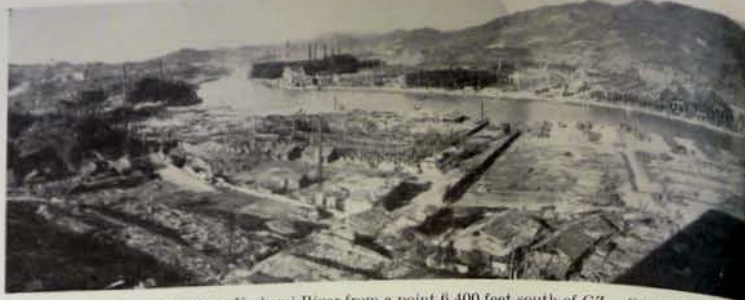
PHOTO 84.—Panorama looking north up Urakami River from a point 6,400 feet south of GZ. Group 26, Mitsubishi Steel and Arms Plant, may be seen on the right bank of the river.

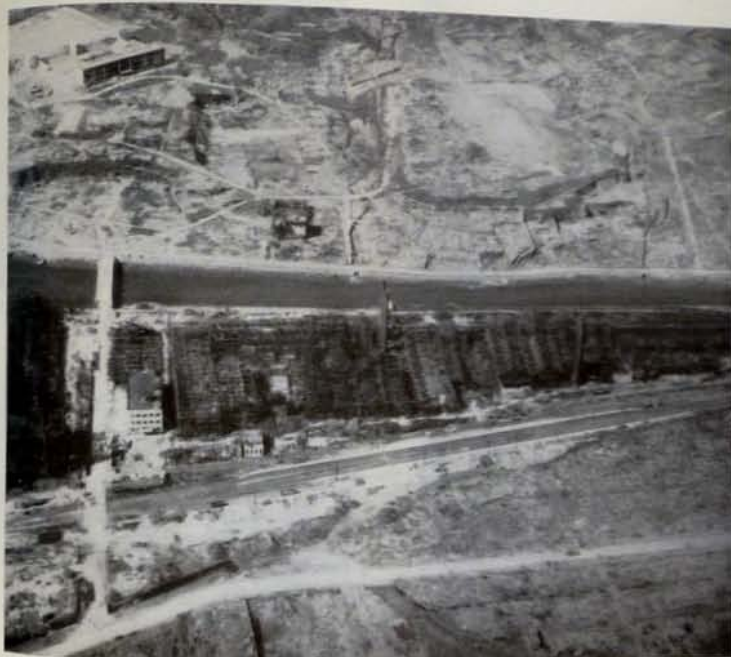
PHOTO 86.—Panorama looking east at Group 26 on east bank of Urakami River.

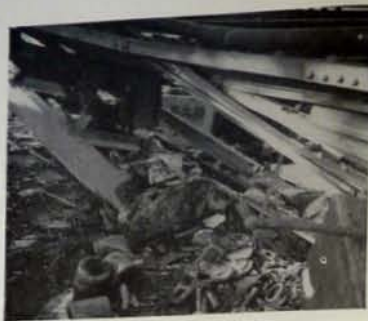
PHOTO 87.—Group 26. Aerial view looking west. Buildings included are Bldg. 5 at right to Bldg. 15 at left.

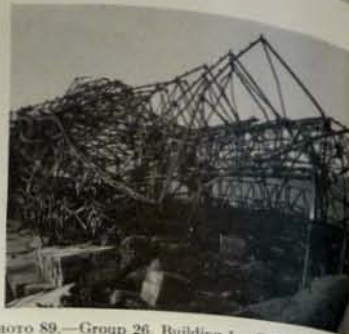
PHOTO 88.—1,500 feet from GZ. Group 26, Building 1. Base of column on west side.

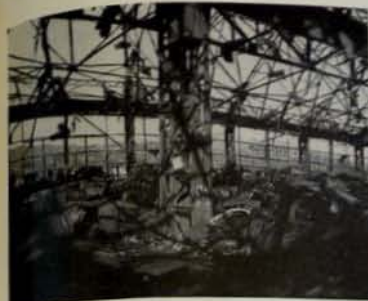
PHOTO 89.—Group 26, Building 1. General view looking southwest.

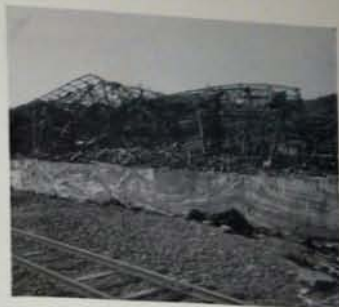
Remarks: Figure 15; Photos 92, 93, and 94.

PHOTO 94.—Group 26, Building 3. Typical column in west wall.

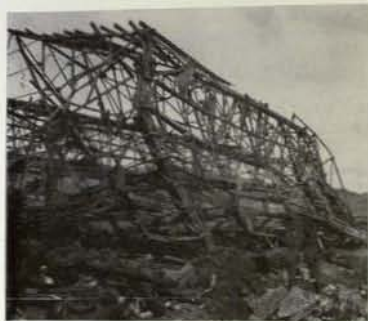
PHOTO 95.—Group 26, Building 4. Looking southwest at collapsed structure.

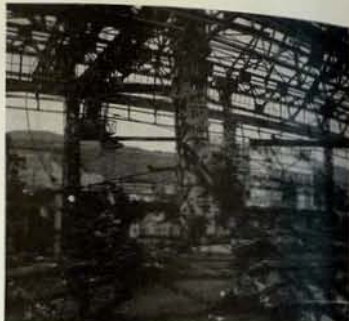
PHOTO 90.—Group 26, Building 1. Looking west at building collapsed toward the south.

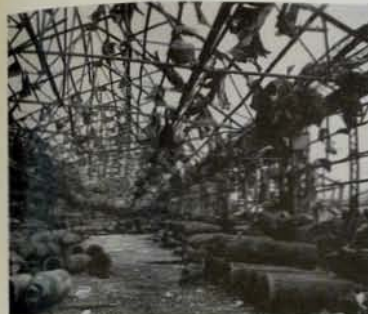
PHOTO 91.—1,500 feet from GZ. Group 26, Building 1. Interior, looking northwest.

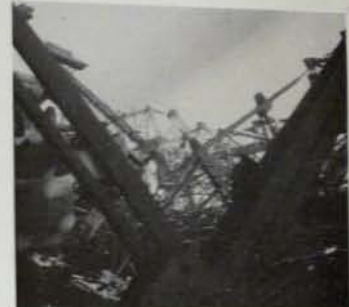
PHOTO 96.—Group 26, Building 4. Interior, looking north.

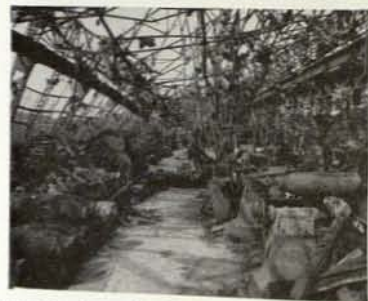
Remarks: Building collapsed toward south. Figure 15; Photo 97.

PHOTO 97.—Group 26, Building 5. Interior, showing damage.

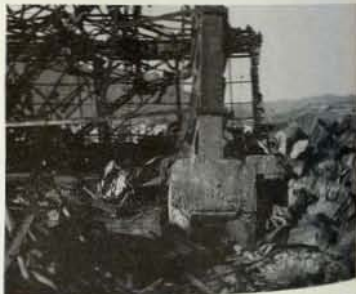
PHOTO 92.—Group 26, Building 3. Interior, looking north.

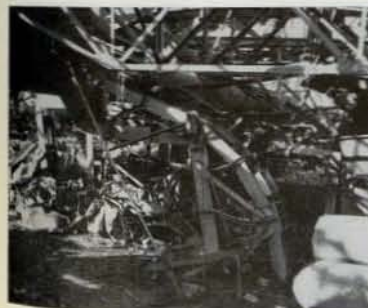
PHOTO 93.—Group 26, Building 3. Tilted column at northeast corner.

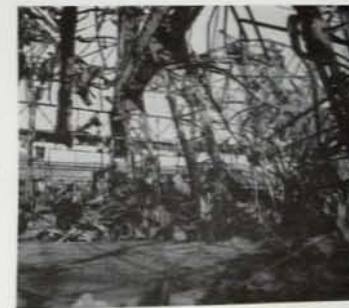
Remarks: Figure 15; Photo 98.

PHOTO 98.—1,700 feet from GZ. Group 26, Building 6. Looking southwest at deformed column.

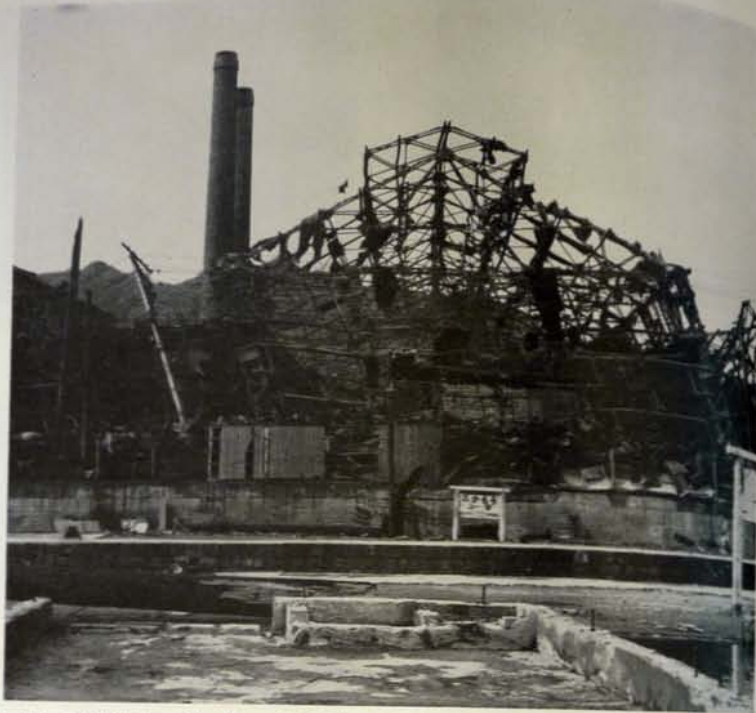
Remarks: Building collapsed in a southwesterly direction. Figure 15; Photos 99 and 101.

PHOTO 99.—Group 26, Building 7. Column leaning south along north wall of building.

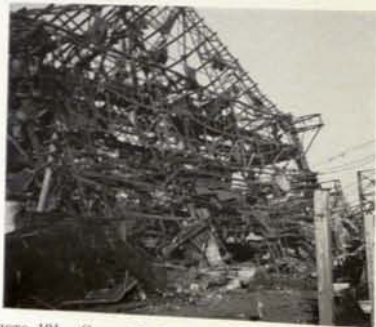
Remarks: Figure 14; Photos 100 and 102.

Photo 100.—2,100 feet from GZ. Group 26, Building 9. Looking west at building collapsed toward the south.

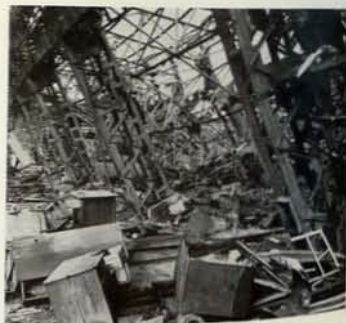
Photo 101.—Group 26, Building 7. Looking southwest at building collapsed toward the south.

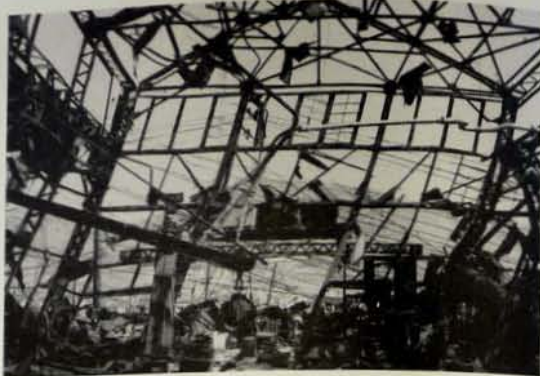
Remarks: Figures 16 and 17; Photos 103 through 107.

Photo 104.—2,800 feet from GZ. Group 26, Building 10A. Interior, looking east.

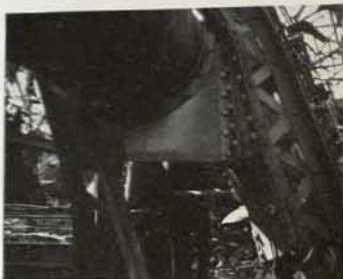
Photo 105.—Group 26, Building 10A. Column 3B bent eight feet from the ground.

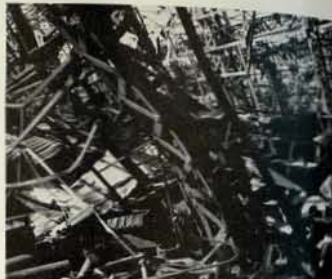
Photo 106.—Group 26, Building 10A. Looking west at base of Column 2A.

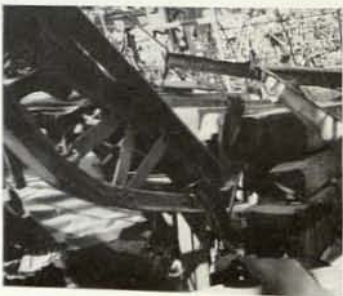
Photo 107.—Group 26, Building 10A. Looking northwest at base of Column 3 1/2 A.

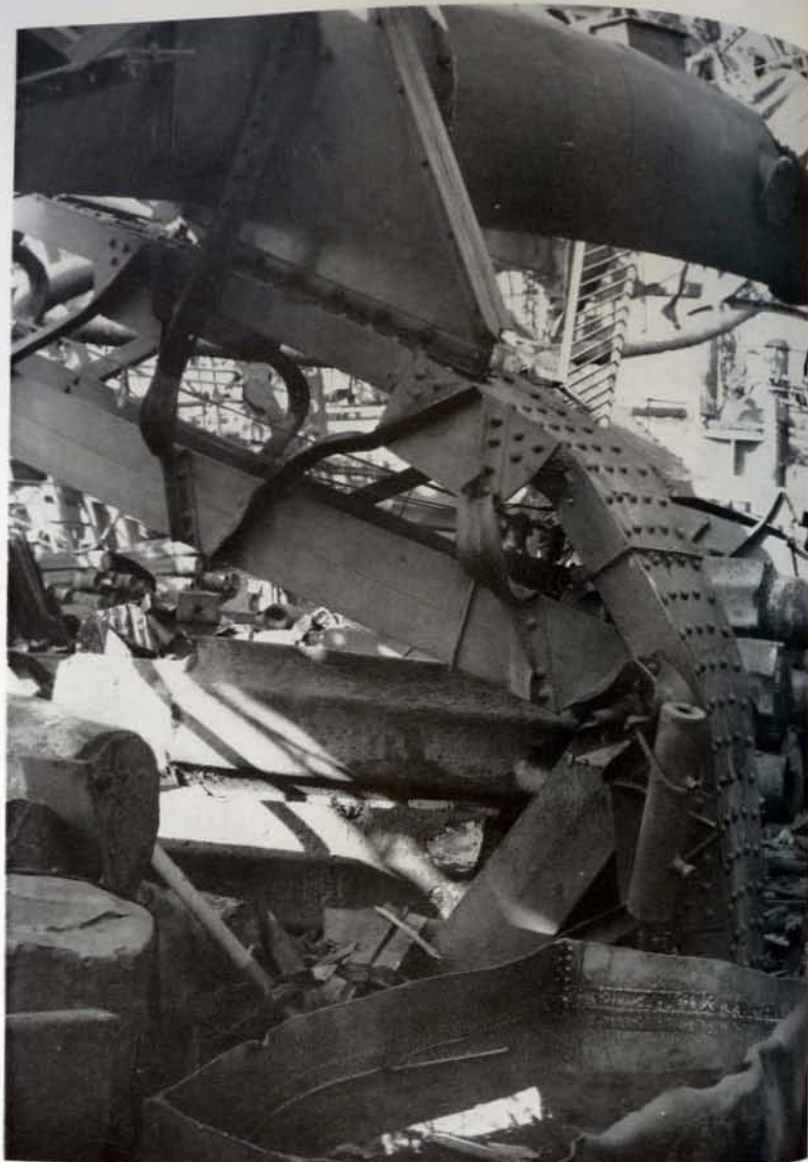
Construction	Damage			Description of damage
	Structural (percent)	Superficial (percent)	Cause	
Roof: Corrugated iron	0	100	Blast	All trusses but one distorted. Columns failed to south. Photos 108, 109, and 110.
Trusses: Steel	90	0	do	
Columns: Steel	100	0	do	
First floor: 5-6 inches concrete on earth.	0	0		
Foundation: Concrete piers	0	0		
Exterior walls: Corrugated iron	0	100	Blast	
Windows: Steel sash	0	100	do	
Contents: 3 cranes	0	100	Weather

Remarks: Figure 17; Photos 108, 109, and 110.

Photo 110.—3,200 feet from GZ. Group 26, Building 11A. Looking southwest at column in north wall.

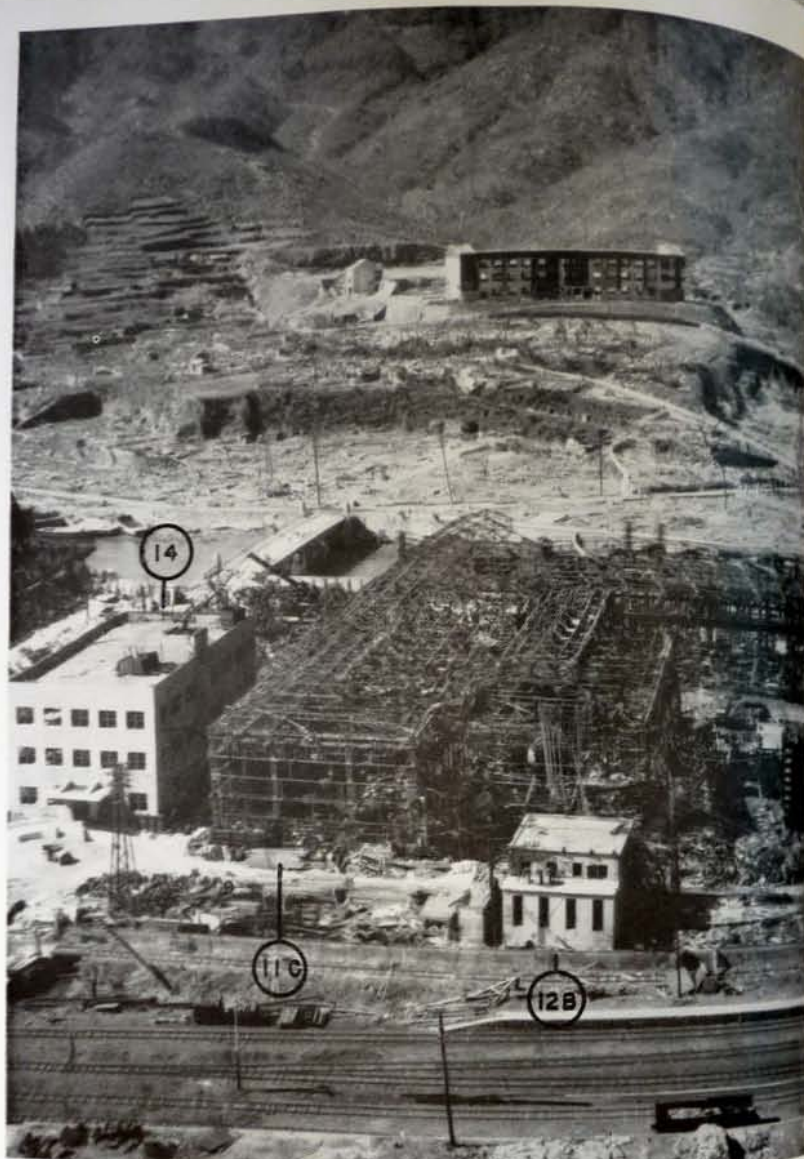
Remarks: Wood plank and dirt blast walls—2 sides—south and west. Figure 14; Photos 113 and 117.

Photo 113.—3,200 feet from GZ. Group 26, looking west. Building 12B in the foreground.

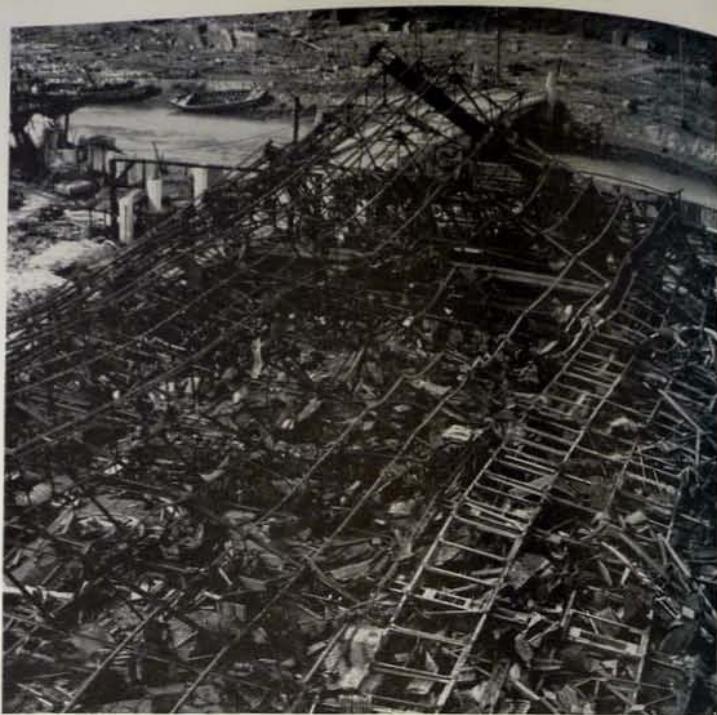
Construction	Damage			Description of damage
	Structural (percent)	Superficial (percent)	Cause	
Roof: Corrugated iron.....	0	100	Blast.....	Building completely collapsed to south. Photos 114 and 115.
Trusses: Steel.....	100	0	do.....	
Columns: Steel.....	100	0	do.....	
First floor: 5-6 inches concrete on earth.....	40	0	do.....	Overturned.
Foundation: Concrete piers 2 by 2 by 5 feet.....	40	0	do.....	
Exterior walls: Corrugated iron.....	0	100	do.....	
Windows: Steel sash.....	0	100	do.....	
Contents: Foundry equipment.....	25	0	do.....

Remarks: Building received a 500-pound HE bomb, 8 Aug. 1945. Figure 14; Photos 114 and 115.

Photo 115.—3,500 feet from GZ. Group 26, Building 13. Looking west at wreckage of structure.

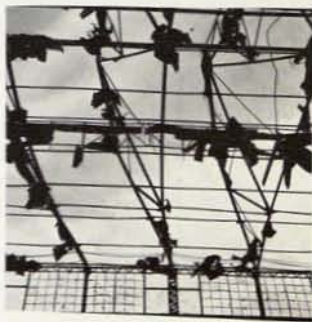
Construction	Damage			Description of damage
	Structural (percent)	Superficial (percent)	Cause	
Roof: Corrugated iron.....	0	100	Blast.....	Trusses lean south approximately 8 feet at top. No longitudinal bracing. Photo 116.
Trusses: Steel.....	100	0	do.....	
Columns: Steel.....	0	0	.....	
First floor: 5-6 inches concrete on earth.....	0	0	.....	
Foundation: Concrete piers.....	0	0	.....	
Exterior walls: Corrugated iron.....	0	100	.....	
Contents: 2 cranes.....	0	0	.....

Remarks: Figure 17; Photo 116.

Photo 116.—3,300 feet from GZ. Group 26, Building 11B. Looking west. Trusses.

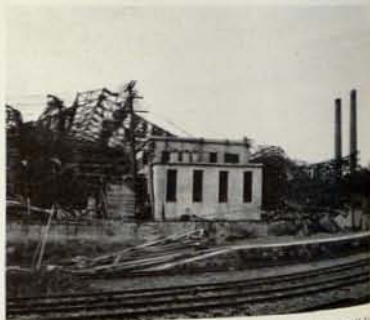
Photo 117.—3,200 feet from GZ. Group 26, Building 12B. Transformer building from the east.

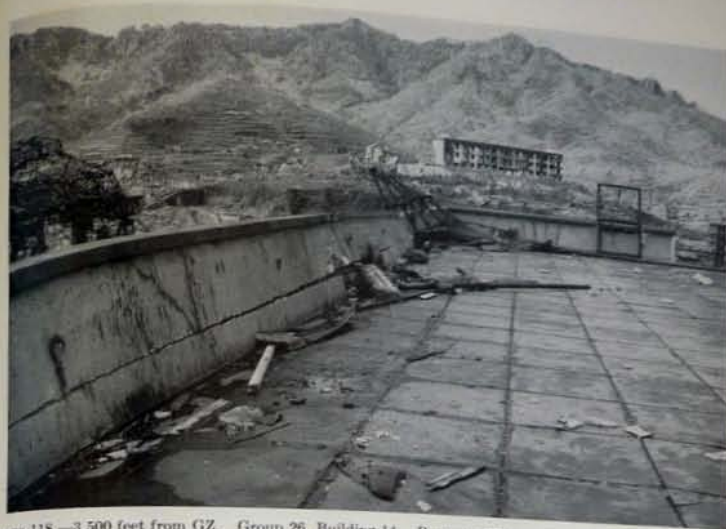
Construction	Damage			Description of damage
	Structural (percent)	Superficial (percent)	Cause	
Roof: Reinforced concrete.....	10	0	Blast.....	3-foot parapet and 3 roof beams cracked. Photos 118 and 119.
Columns: Reinforced concrete.....	0	0	.....	
Third floor: Reinforced concrete.....	0	0	.....	
Second floor: Reinforced concrete.....	0	0	.....	
First floor: Reinforced concrete.....	0	0	.....	
Basement: Reinforced concrete.....	0	0	.....	
Foundation: Reinforced concrete.....	0	0	.....	
Exterior walls: Reinforced concrete.....	0	0	.....	
Interior walls: Lath and plaster.....	0	100	Blast.....	do.....
Windows: Steel sash.....	0	100	do.....	
Finish: Plaster.....	0	20	do.....

Remarks: Figure 14; Photos 118 and 119.

Photo 118.—3,500 feet from GZ. Group 26, Building 14. Parapet wall in south wall of building leaning south.

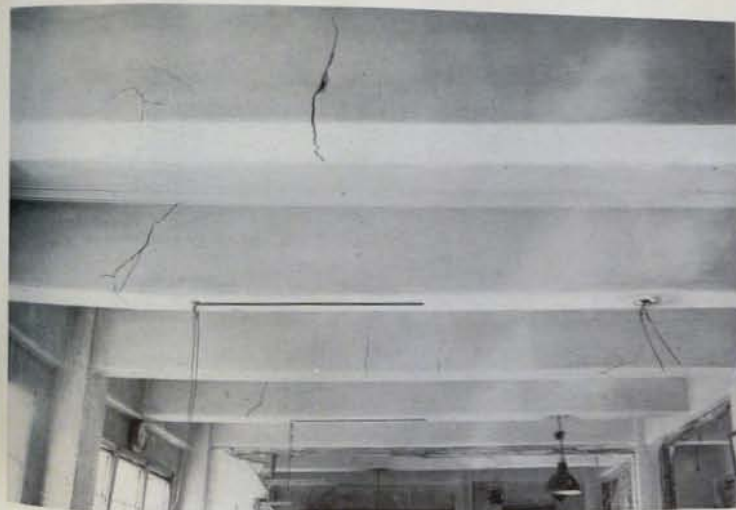
Photo 119.—Group 26, Building 14. Cracked roof beams at southwest corner of building.

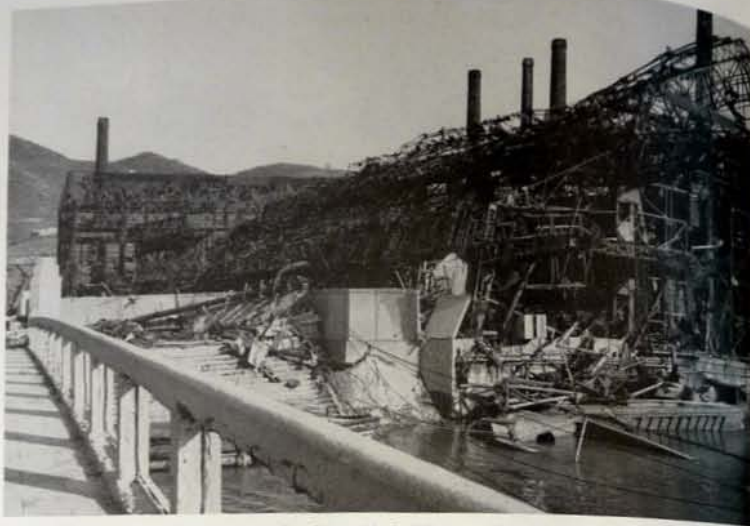
Construction	Damage		Cause	Description of damage
	Structural (percent)	Superficial (percent)		
Roof: Corrugated iron	0	100	Blast	Building collapsed to south. Photo 120.
Trusses: Steel	50	0	do	
Columns: Steel	75	0	do	
First floor: Concrete	0	0	Debris	Derailed by building. Distortion.
Foundation: Spread footings	20	0	Blast	
Exterior walls: Corrugated iron	0	100	do	
Windows: Steel sash	0	100	do	
Contents: Cranes	100	0	do

Remarks: Plate crane girder collapsed; open crane truss O. K. Figure 18; Photo 120.

PHOTO 120.—3,700 feet from GZ. Group 26, Building 15. Looking east from Bridge 12.

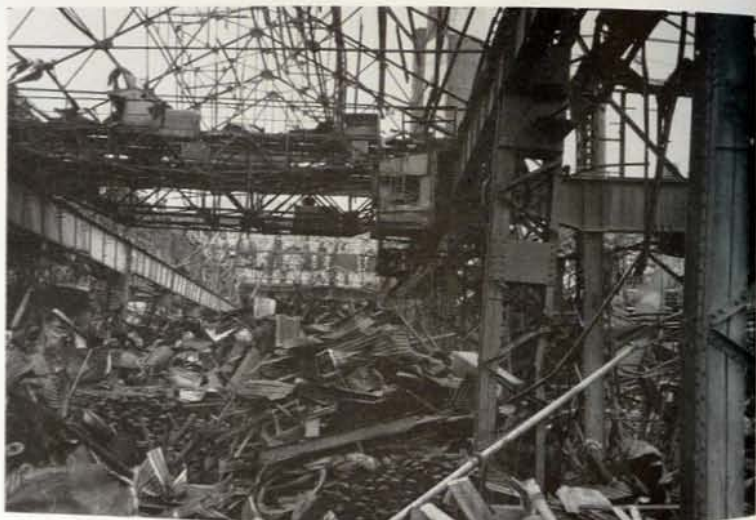
Construction	Damage		Cause	Description of damage
	Structural (percent)	Superficial (percent)		
Roof: Corrugated iron	0	100	Blast	Leans to south. Photo 121.
Trusses: Steel	100	0	do	
Columns: Steel	100	0	do	
First floor: Earth	0	0	do	Uprooted.
Foundation: Concrete	30	0	Blast	
Exterior walls: Corrugated iron	0	100	do	
Windows: Steel sash	0	100	do	Derailed and dropped.
Contents: Cranes	40	0	do

Remarks: Figure 18; Photo 121.

PHOTO 121.—3,900 feet from GZ. Group 26, Building 16. Interior, looking east.

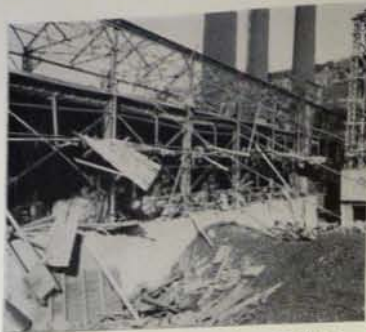
Remarks: Figures 18 and 19; Photo 123.

PHOTO 123.—3,900 feet from GZ. Group 26, Building 17. Looking north at south elevation.

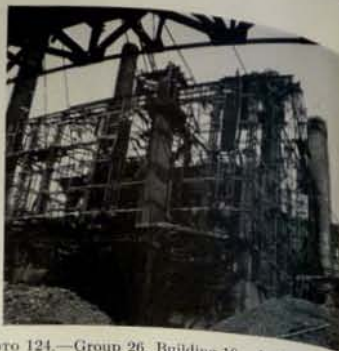
Construction	Damage			Description of damage
	Structural (percent)	Superficial (percent)	Cause	
Roof: Corrugated iron	0	100	Blast	Bent 1-2 feet to south. Photos 124 and 125.
Trusses: Steel	20	0	do	
Columns: Steel	50	0	do	
First floor: Reinforced concrete	0	10	Debris	
Basement: Reinforced concrete	0	0		
Foundation: Reinforced concrete	0	0		
Exterior walls: Corrugated iron	0	100	Blast	
Windows: Steel sash	0	100	do	
Contents: Conveying equipment	0	10	Debris	
boilers and equipment.

Remarks: Figure 20; Photos 124 and 125.

PHOTO 124.—Group 26, Building 18. Looking northeast.

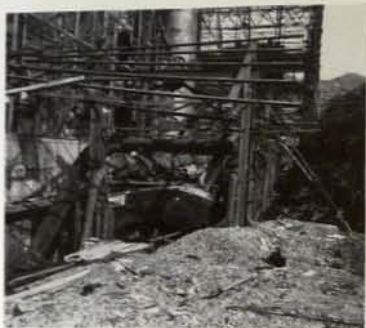
PHOTO 125.—Group 26, Building 18. Brick oven at south side of building.

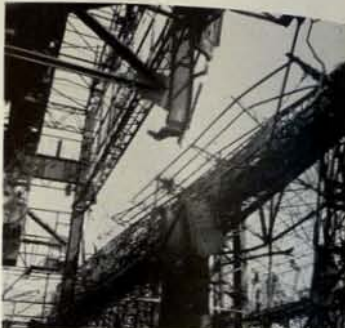
Construction	Damage			Description of damage
	Structural (percent)	Superficial (percent)	Cause	
Roof: Corrugated iron	0	100	Blast	Photos 122 and 127. Photos 126, 128, and 130.
Trusses: Steel	0	0		
Columns: Steel	3	0	H. E. b o m b blast.	
First floor: Concrete	0	0		See photo 128. Photos 127 and 131.
Basement: Corrugated iron	0	100	Blast	
Windows: Steel sash	0	100	do	
Contents: 1 180-ton crane; 1 70-ton crane.	0	0

Remarks: Heavy construction; minor damage only. Figures 18 and 19; Photos 122, 126, 127, 128, 130, and 131.

PHOTO 126.—Group 26, Building 19. Column cut by H.E. bomb.

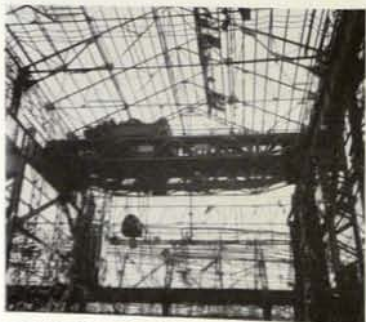
PHOTO 127.—Group 26, Building 19. Looking south at 180-ton crane.

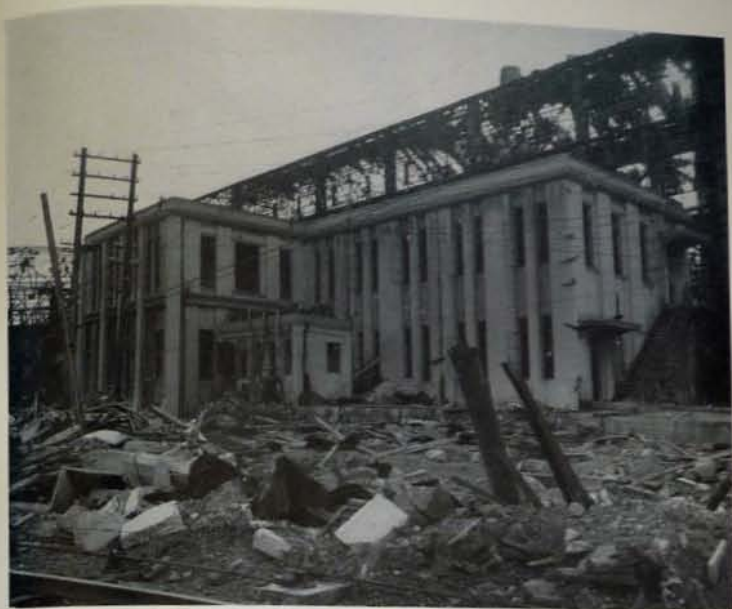
PHOTO 129.—3,900 feet from GZ. Group 26, Building 20. General view looking southwest.

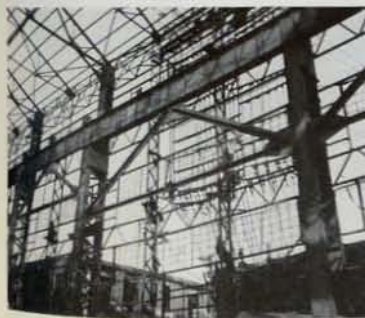
PHOTO 130.—Group 26, Building 19. Typical construction in south half of building.

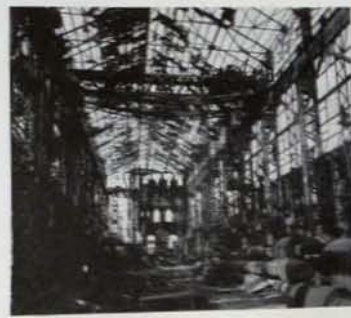
PHOTO 131.—Group 26, Building 19. Looking north at 180-ton crane.

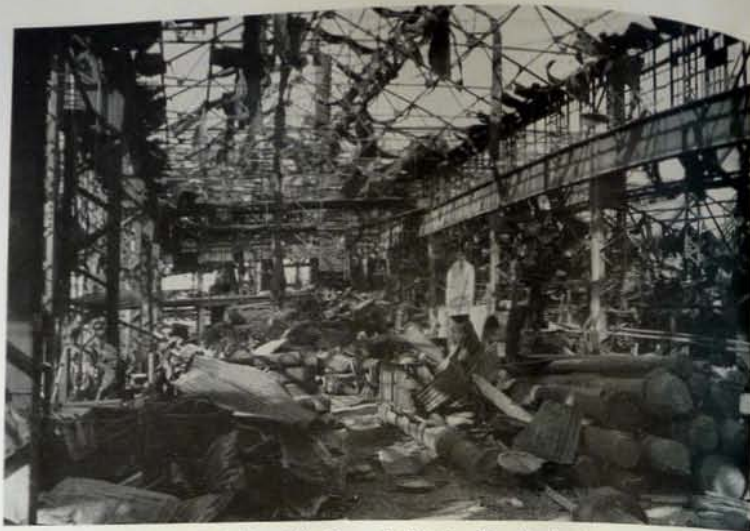
PHOTO 132.—3,900 feet from GZ. Group 26, Building 22. Interior, looking north.

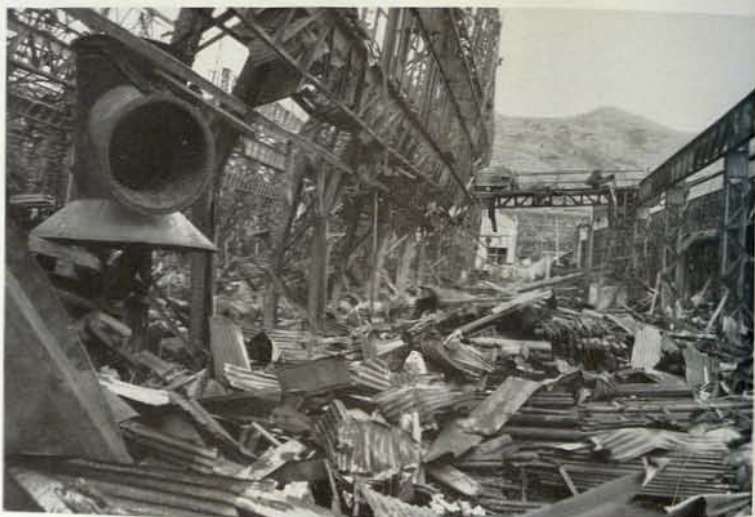
PHOTO 133.—4,100 feet from GZ. Group 26, Building 23. Looking east at columns in south wall.

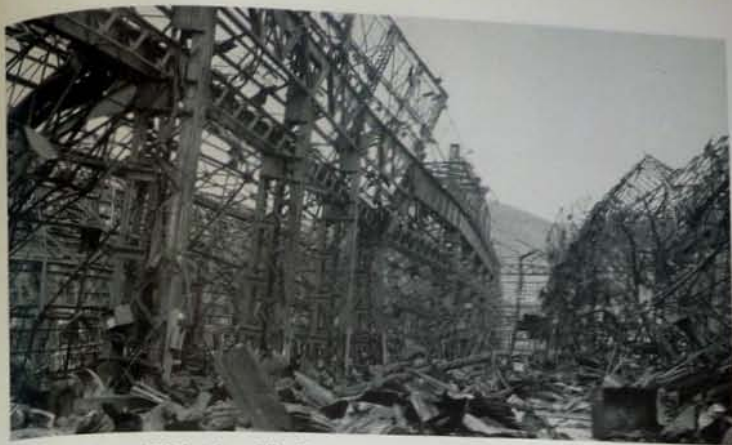
Construction	Damage			Description of damage
	Structural (percent)	Superficial (percent)	Cause	
Roof: Corrugated iron	0	100	Blast	North line main columns O.E. crane girders overturned; all trusses failed. Row (B) columns failed either by bending or breaking from foundations. Row (A) columns failed in bending. Photos 134, 135, 137, and 138.
Trusses: Steel	100	0	do	
Columns: Steel	40	0	do	
First floor: Earth				
Foundation: Reinforced concrete	0	0		
Exterior walls: Corrugated iron	10	0	Blast	
Windows: Steel sash	0	100	do	
Contents: Transformer station	0	100	do	
	0	5	Weather

PHOTO 134.—4,100 feet from GZ. Group 26, Building 23. Looking east at internal column row.

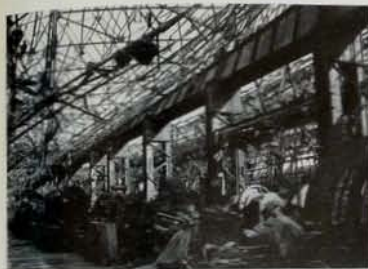
PHOTO 135.—Group 26, Building 23. Looking southeast at internal column row.

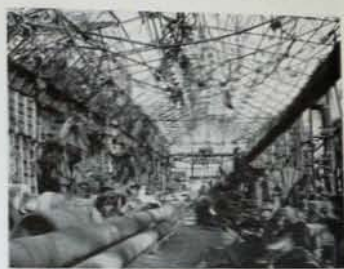
PHOTO 136.—Group 26, Building 23. Interior. Looking east.

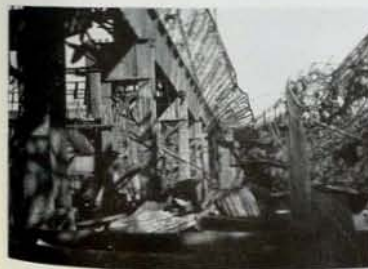
PHOTO 137.—Group 26, Building 23. Looking east along main column line.

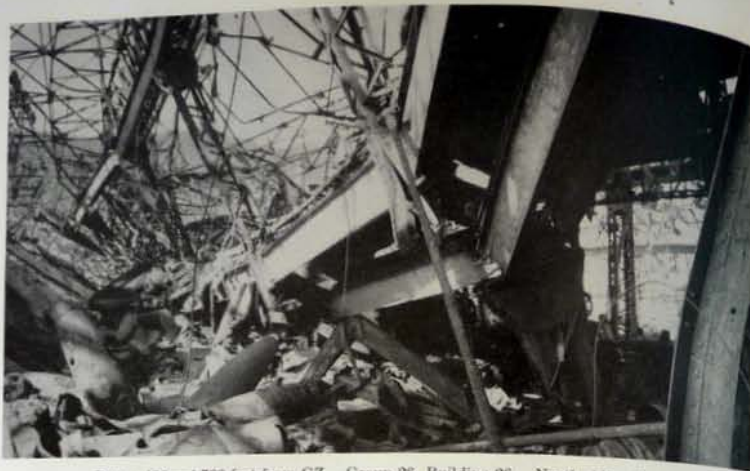
Construction	Damage			Description of damage
	Structural (percent)	Superficial (percent)	Cause	
Roof: Wood	0	100	Fire and blast	Photo 139.
Trusses: Steel	100	0	do	
Columns: Steel	90	0	do	
Second floor: Reinforced concrete on steel	100	0	do	
First floor: Reinforced concrete on ground	0	20	Debris	Derailed and down.
Foundation: Reinforced concrete	0	0		
Exterior walls: Corrugated iron	0	100	Fire and blast	
Windows: Steel sash	0	100	do	
Contents: Traveling cranes	0	50	Blast

Photo 139.—4,700 feet from GZ. Group 26, Building 26. North side collapsed.

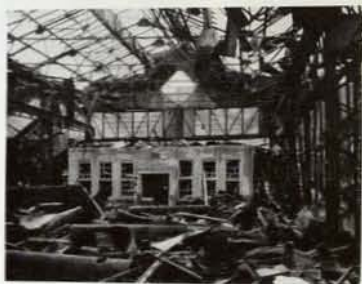
Construction	Damage			Description of damage
	Structural (percent)	Superficial (percent)	Cause	
Roof: Corrugated iron	0	100	Blast	Canted south; some bent; crippled at north end. Photos 138 and 140. Upturned. End wall of reinforced concrete; sidewalls of reinforced concrete and corrugated iron.
Trusses: Steel	100	0	do	
Columns: Steel	80	0	do	
First floor: Reinforced concrete	0	10	Debris	
Foundation: Reinforced concrete	40	0	Blast	
Exterior walls: Reinforced concrete and corrugated iron	0	100	do	
Windows: Steel sash	0	100	do	
Contents: Traveling cranes	0	50	do

Photo 140.—4,300 feet from GZ. Group 26, Building 25. Small office in west end of building.

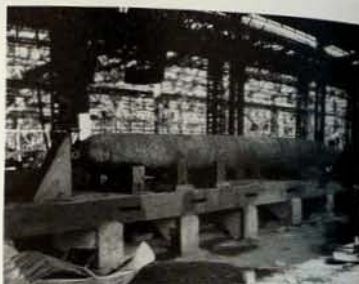
Photo 141.—Group 26, Building 26. Torpedo assembly equipment.

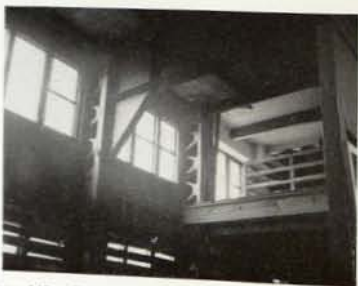
Photo 142.—Group 26, Building 27. Typical construction.

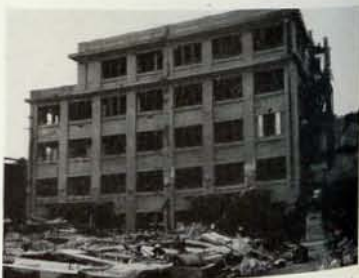
Photo 143.—Group 26, Building 27. General view looking west.

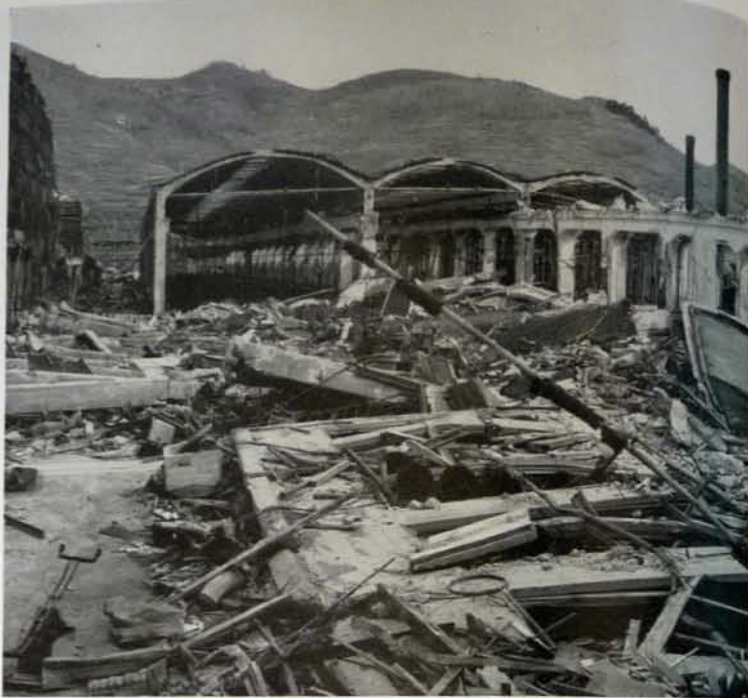
Construction	Damage			Description of damage
	Structural (percent)	Superficial (percent)	Cause	
Roof: Reinforced-concrete arch	50	0	Blast	Arch collapsed down. Photo 148.
Columns: Reinforced concrete	40	0	do	
First floor: Reinforced concrete	10	0	do	Uprooting of columns and wall footings. Photo 145, 152, and 153.
Foundation: Reinforced concrete	15	0	do	
Exterior walls: Reinforced concrete	30	0	do	
Windows: Wood sash	0	100	do	
Contents: 3 traveling cranes	0	0

PHOTO 145.—4,600 feet from GZ. Group 26, Building 29. Looking east at destroyed west portion of building.

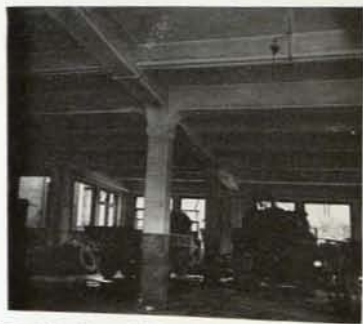
PHOTO 146.—Group 26, Building 28. Typical construction on first floor.

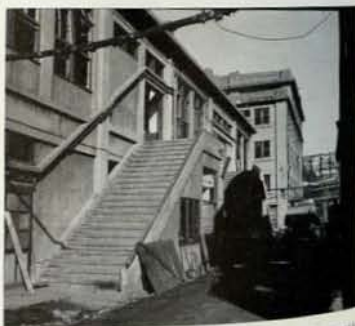
PHOTO 147.—Group 26, Building 28. Looking north at east wall of building.

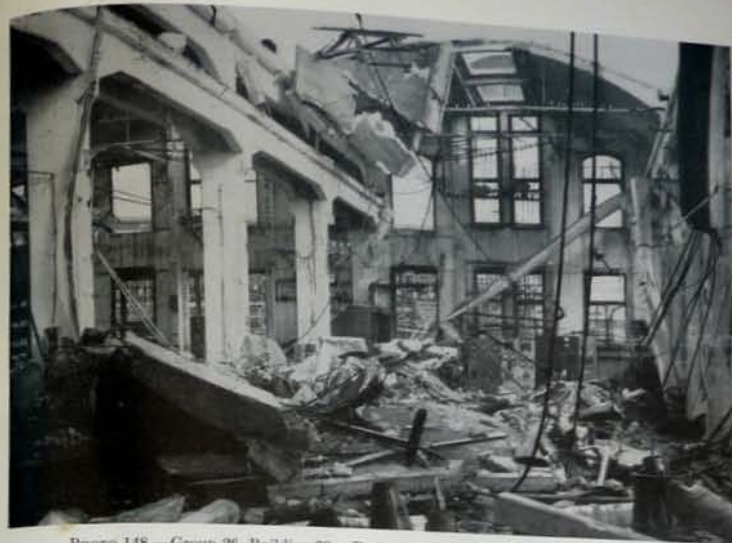
PHOTO 148.—Group 26, Building 29. Destroyed section in southeast corner of building.

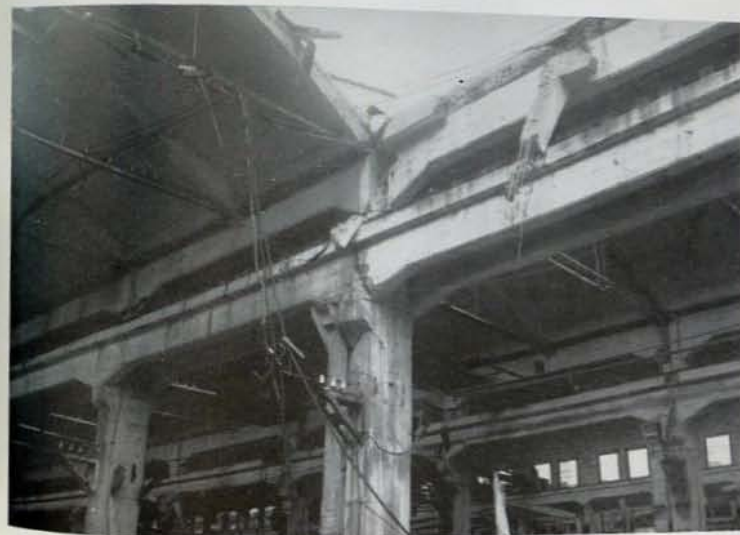
PHOTO 149.—Group 26, Building 29. Top of Column 20B. Typical of roof collapse stopping at expansion joints.

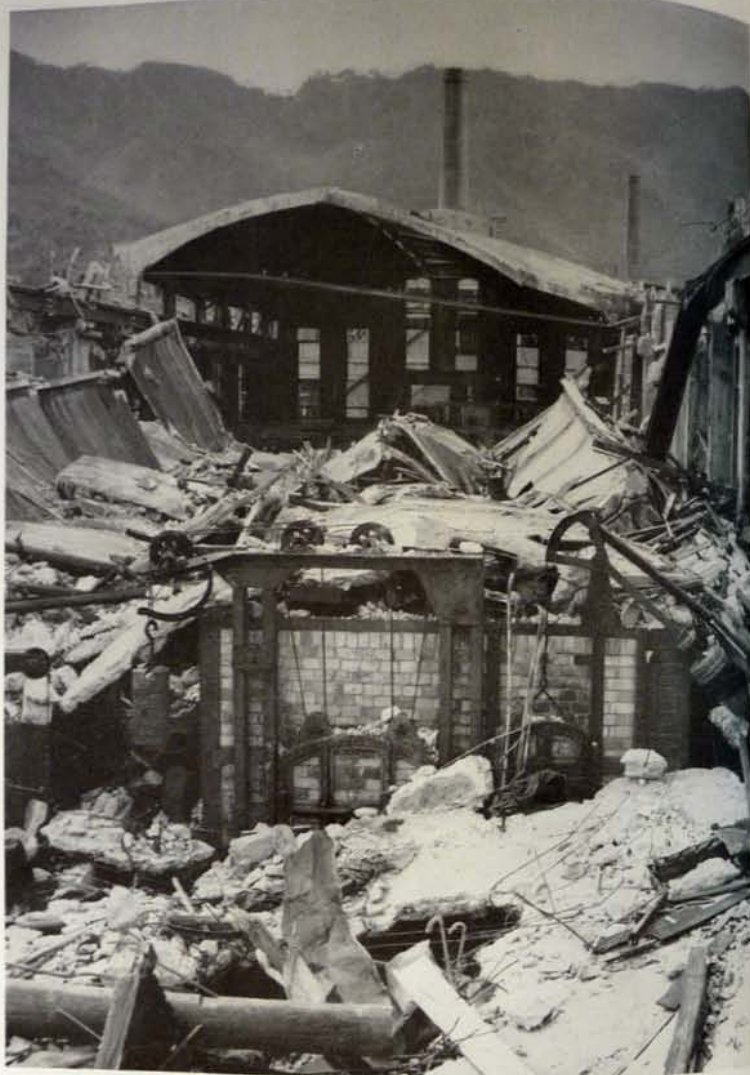
Construction	Damage			Description of damage
	Structural (percent)	Superficial (percent)	Cause	
Roof: 4-inch, reinforced-concrete arch slab on reinforced-concrete ribs.	100	0	Blast	Arch collapsed down. Photo 150.
Columns: Reinforced concrete	30	0	do	
First floor: Reinforced concrete	0	50	Debris	
Foundation: Reinforced concrete	0	0		
Exterior walls: 6-inch reinforced concrete.	30	0	Blast	
Windows: Wood sash		100	do	
Contents: Traveling cranes	100	0	do

PHOTO 150.—4,700 feet from GZ. Group 26, Building 30. Looking west at debris of arched concrete roof. Note walls remain in place.

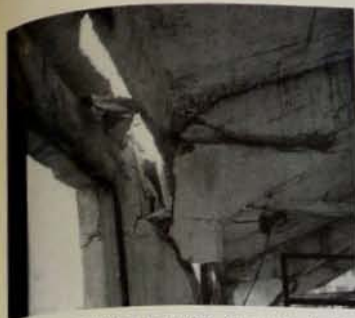
PHOTO 151.—4,600 feet from GZ. Group 26, Building 29. Top of Column 14A. Typical of failure in Columns 12½A through 16½A in south wall of building.

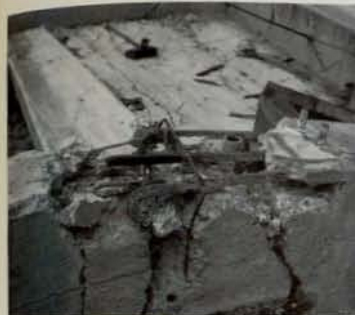
PHOTO 153.—Group 26, Building 29. Collapsed Column 9D at a point 20 feet from base. Note steel spliced with small lap.

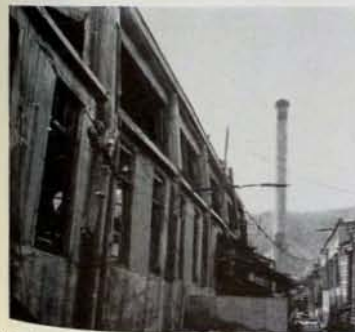
Construction	Damage			Description of damage
	Structural (percent)	Superficial (percent)	Cause	
Roof: 6-inch, reinforced-concrete arch slab on 12- by 18-inch reinforced-arch ribs.	100	0	Blast	Collapsed. Photos 154, 155.
Columns: 12- by 30-inch reinforced concrete.	90	0	do	Photo 155.
First floor: Reinforced concrete	0	0	do	
Foundation: Reinforced concrete	50	0	Blast	
Exterior walls: 10- by 6-inch reinforced concrete.	95	0	do	Photo 156.
Windows: Wood sash	0	100	do	
Contents: Traveling crane	20	0	do	
Machine tools	100	0	do

PHOTO 155.—Group 26, Building 31. Fractured column in south wall leaning south.

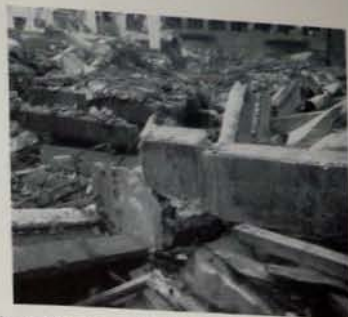
PHOTO 152.—Group 26, Building 29. Base of Column 8½D. Typical of failure along north wall at west end of building.

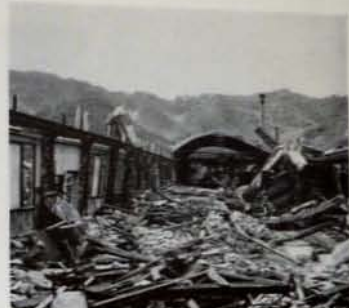
PHOTO 154.—4,700 feet from GZ. Group 26, Building 31. Looking east at debris of arched concrete roof.

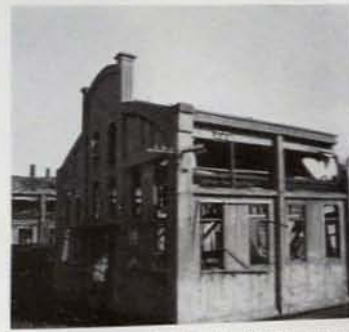
PHOTO 156.—Group 26, Building 31. Southwest corner of building showing typical construction.

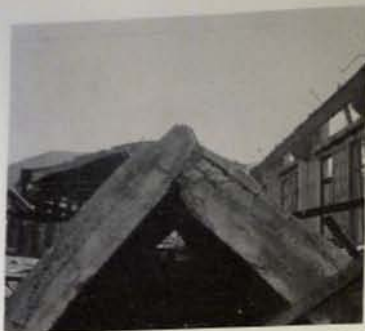
PHOTO 157.—Group 26, Building 31. Broken roof slab on ground. Poor construction shown in insufficient splicing of steel rods.

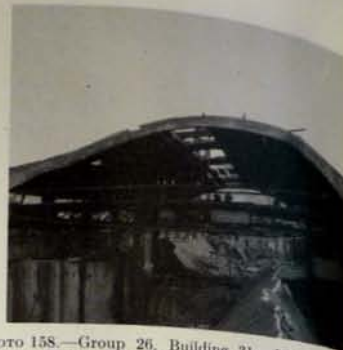
PHOTO 158.—Group 26, Building 31. Looking east at damaged, but still standing, portion of arched roof wall.

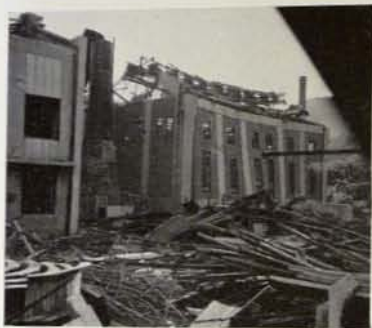
Construction	Damage			Description of damage
	Structural (percent)	Superficial (percent)	Cause	
Roof: Corrugated iron	0	100	Blast	Photo 159.
Trusses: Steel	85	0	do	
Columns: Steel	60	0	do	
First floor: Reinforced concrete on earth.	0	5	Debris	
Foundation: Reinforced concrete	0	0		
Exterior walls: Steel-frame, 6-inch, concrete panels, very light.	60	0	Blast	North and south walls bowed southward by blast. East and west walls gone. Photo 159.
Windows: Steel sash	0	100	do	
Contents: Boilers and accessories	0	10	Blast and debris

PHOTO 159.—4,700 feet from GZ. Group 26, Building 32. Destroyed roof and north wall of building.

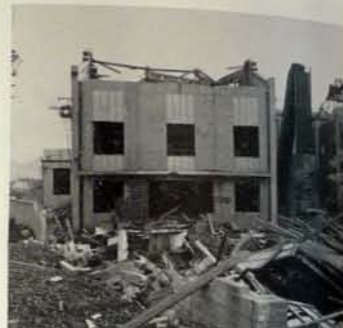
Construction	Damage			Description of damage
	Structural (percent)	Superficial (percent)	Cause	
Roof: Corrugated iron and wood	0	90	Blast	Photo 160.
Trusses: Steel	100	0	do	
Columns: 18- by 23-inch reinforced concrete.				
Mezzanine floor: Steel	0	40	Shock	Jolted down but not damaged.
First floor: Reinforced concrete	0	0		
Foundation: Reinforced concrete	25	0	Blast	Photo 160.
Exterior walls: 9-inch reinforced concrete.				
Windows: Steel sash	0	100	do	
Contents: Transformers, switches and crane.	0	0

PHOTO 160.—4,700 feet from GZ. Group 26, Building 33. Damaged roof and north wall of transformer building.

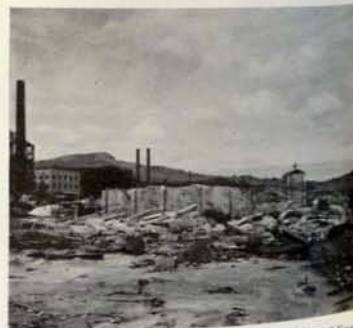
These buildings completely destroyed by blast and fire. Photos 162 and 163.

PHOTO 162.—4,800 feet from GZ. Group 26, Building 40. Looking north.
